2012 NYCT Steinway Tube – Duct Bench Rehabilitation

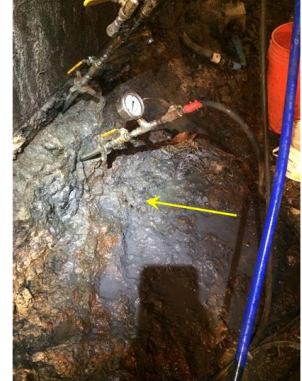
Leak Area

Drilled Hole with Packer

Dyed Inhibitor
Confirming Connection

NOH2O Sealing the Leak
